# BELZONA 2141 PROTECTS SHIPS RUDDER AGAINST CAVITATION

ID: 2160

## PROBLEM

Cavitation erosion occurring on lower section of the rudder.

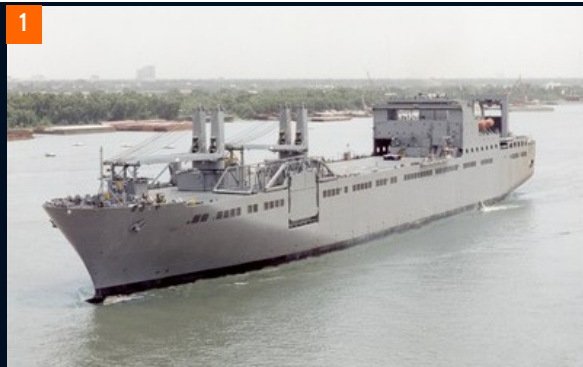
1. The ship at sea
2. Surface preparation
3. After the application of Belzona 2141
4. Another view of the rudder after the application of Belzona 2141

Application was carried out in accordance with Belzona System Leaflet SOS-2.
