# BELZONA RAPID REPAIR TO VIADUCT RAILING SUPPORT

ID: 2161

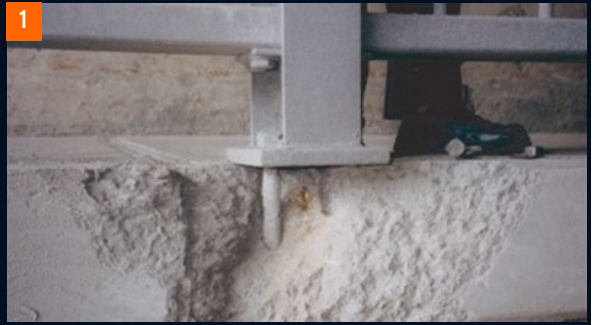
The concrete base for railings support pillars was cracked and spalled.

Concrete condition before the application The concrete is coated with Belzona 4911 Conditioner Belzona 4141 application completed quickly and easily without the use of formwork
