# BELZONA AVOIDS SLIP PROBLEMS

ID: 2162

Drive drums from conveyor system

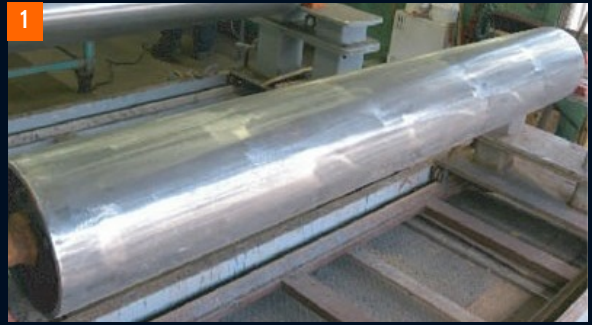
The belt was slipping on the drive rollers due to water from the poor seasonal weather.

1. Steel roller
2. After preparation, coating with Belzona 1321
3. Finished roller

Application carried out according to Belzona Know-How System Leaflet SHM-12.

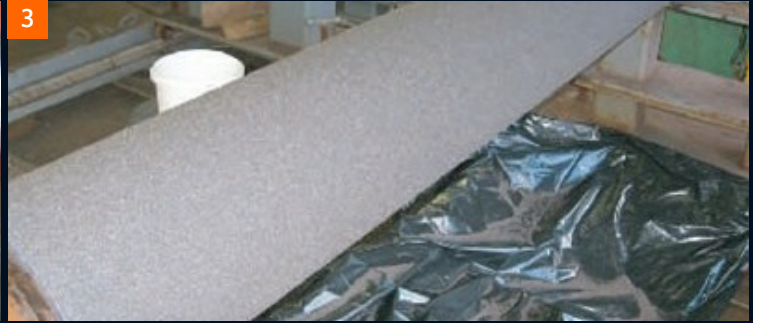
Two drive rollers were treated and performed perfectly for a full year without any evidence of slipping. The Belzona Grip System has performed better than rubber and other lagging systems previously used.
