# BELZONA PROVIDES PROTECTION FROM HOT GASES AT WATER TREATMENT PLANT

ID: 2167

Water treatment plant, Slovakia

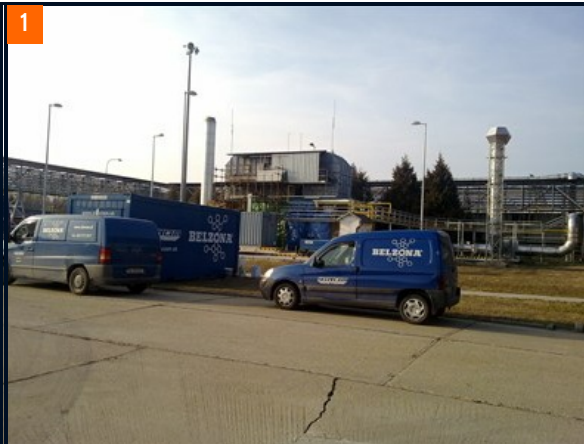
Gases collected from the biological water treatment are processed in thermo-reactor and the gases at 75 – 130°C are corrosive.

1. General view of the reactor
2. Corrosion before repair
3. After grit blasting pitting corrosion clearly evident
4. Inspection after 6 months showed no damage or defects on the coating

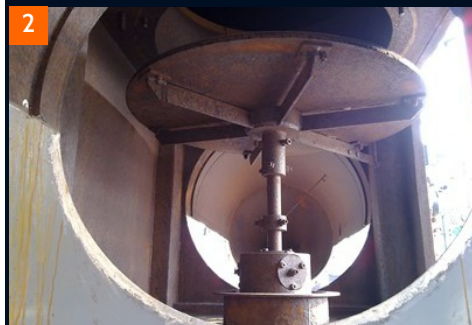
Sulphides, Sulphates, Chlorides, Ammonia, etc. in the gas caused pitting corrosion in the unit after 10 months.

Application was carried out in accordance with Belzona Know-How System Leaflet TCC-5. After grit blasting and chemical cleaning, areas were coated with Belzona® 1392 or Belzona® 4311 (depending on temperature).

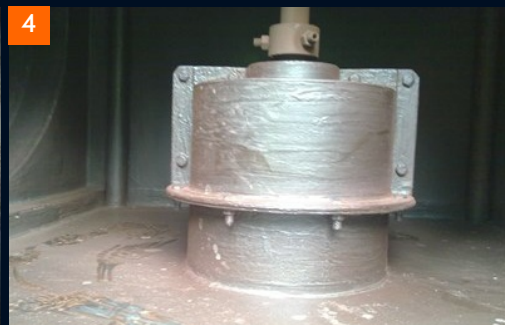
Based on high temperature and various chemicals present, Belzona solution was chosen. After more than 12 months in service no defects have occurred and equipment remains fully protected.
