# BELZONA PROTECTS HYDROELECTRIC TURBINE RUNNER

ID: 218

Francis turbine runner

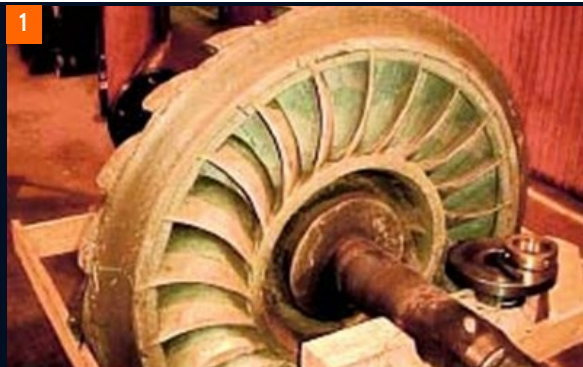
Over 40 years of service led to cavitation and corrosion.

1. The runner prior to application
2. Application underway with second coat of Belzona 1341 being applied
3. The completed application with the smoothness of Belzona 1341 clearly evident
