# BELZONA KEEPS WORN HOSE WORKING

ID: 220

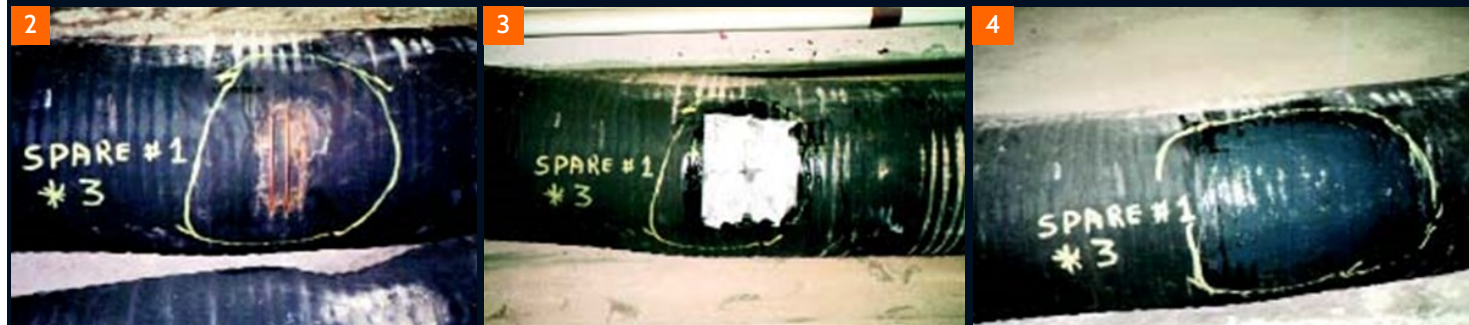
The uploading cement hose had worn through to the reinforcement wire.

1. Overview of damaged area
2. Loose pieces have been removed
3. The conditioner, reinforcement sheet and Belzona 2311 (SR-Elastomer) have been used to fill area
4. The finished repair

Application was carried out in accordance with Belzona Know-How System Leaflet SOS-12.
