# BELZONA REPAIRS AND PROTECTS HYDROELECTRIC TURBINE AND CASING

ID: 2202

Hydroelectric pumped storage turbine and casing

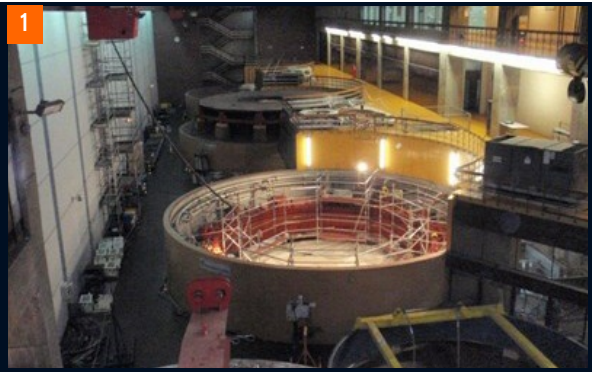
Turbine disassembly Pit filling on the turbine with Belzona 1111 Application of Belzona 1812 after coating the entire stay vane with Belzona 1341 Completed application of Belzona 2141
