# BELZONA REPAIRS ORE BRIDGE CRANE AT BLAST FURNACE

ID: 221

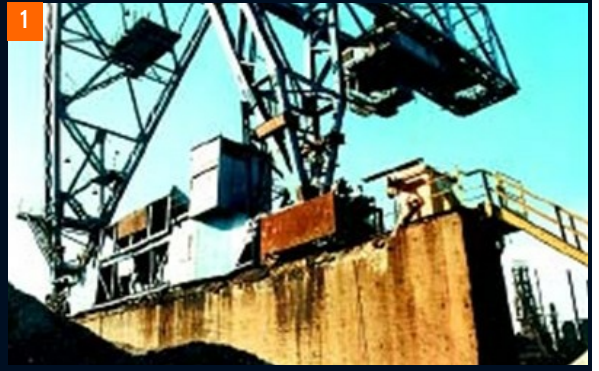
1. Overall view of Ore Bridge crane
2. Template "C"- clamped in place
3. Finished keyway with no machining required

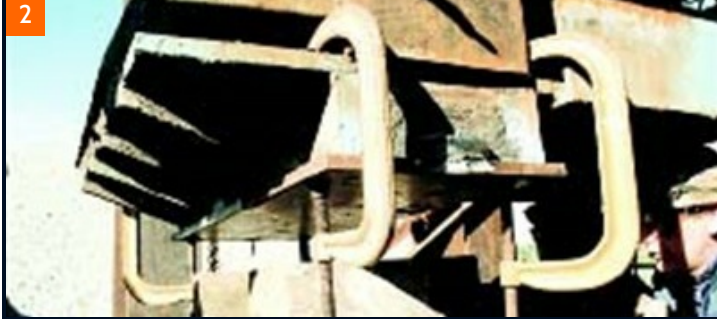
A template with new key stock was made. The template was coated with Belzona® Release Agent and positioned beneath the cranes pedestal. Belzona® 1111 (Super Metal) was then applied.

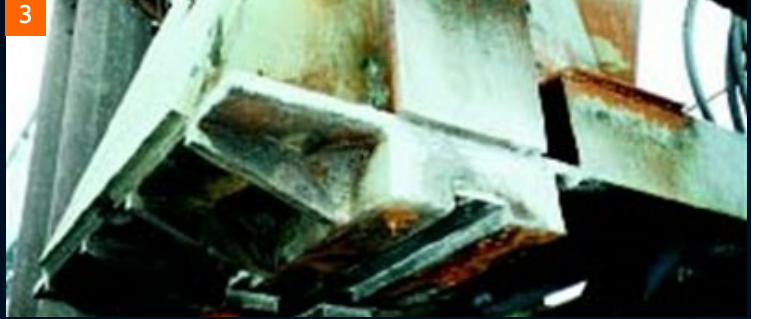
Twenty-four hours later the Ore bridge was back in operation, preventing a 3 to 4 day shutdown to weld and machine a new keyway.
