# BELZONA 1811 PROTECTS OUTPUT SCROLL

ID: 222

The cossette scroll located at the diffuser output.

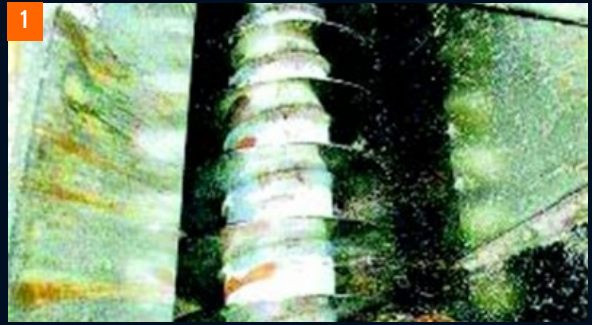
Extensive abrasion, up to 7.5mm (30 mils), of the existing glass flake coating and the 25mm (1 inch) thick tubular shaft.

1. General view of the equipment
2. Application completed with Belzona 1811
3. View of equipment following a campaign in service

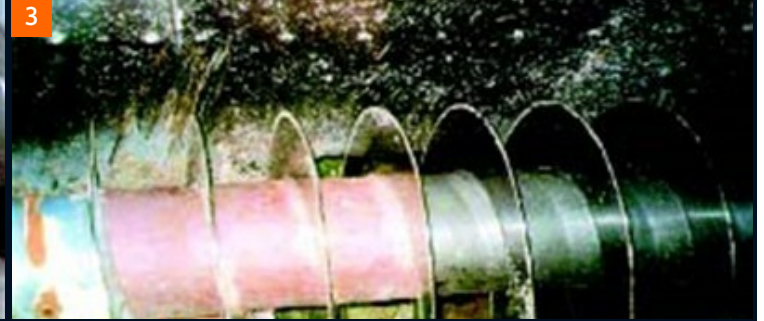
If abrasive wear had continued, it would have ultimately caused the structural failure of the scroll shaft. By protecting the scroll shaft with a Belzona® abrasion resistant material during the annual outage, only minor sacrificial wear of the product occurred, thereby leaving the substrate undamaged. Unlike an "imitator's" system, the Belzona protection was found upon inspection at the next outage to be unaffected.
