# BELZONA 1811 PROTECTS BEET FLUME WELD JOINTS

ID: 223

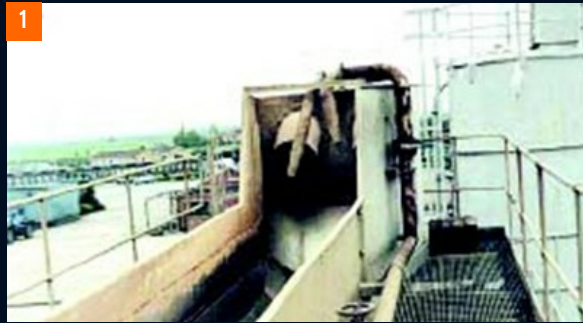
The beet flume located between the beet pumps and the stone catcher.

1. General view of the application site
2. Equipment prior to surface preparation
3. Application completed with the Belzona 1811
