# BELZONA EXTENDS THE LIFE OF HEAT EXCHANGER END COVERS

ID: 2237

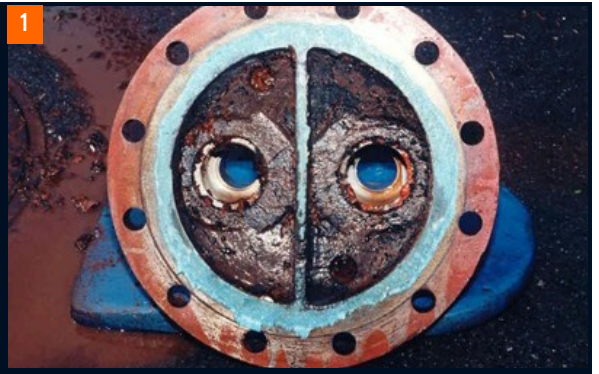
The heat exchanger unit end covers had become so badly eroded that they were potentially scrap.

1. View of corroded end covers after they had been removed
2. End covers after grit blasting
3. End covers rebuilt and coated
