# BELZONA 1391 PROTECTS BEET COSSETTE MINGLER

ID: 224

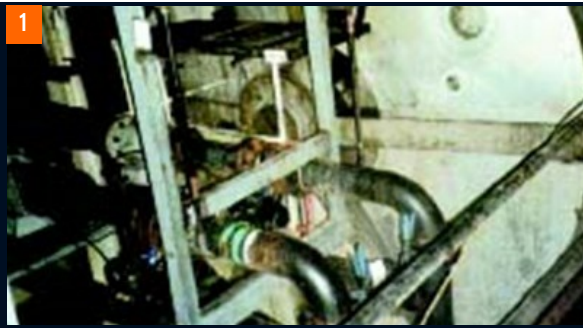
1. General view of the application site
2. Equipment prior to surface preparation
3. Application completed with Belzona 1391

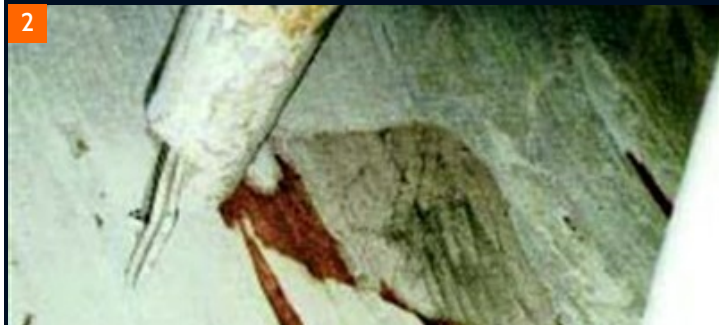
Excessive corrosion and eventual failure of the existing glass flake protection system.
