# BELZONA 1391 PROTECTS JUICE HEATER END COVER

The end cover of a juice heater.

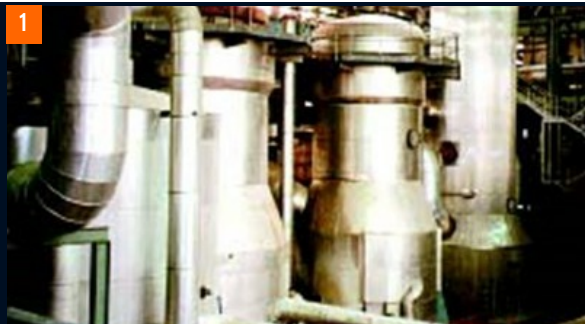
1. General view of the application site
2. Equipment prior to surface preparation
3. Application completed with Belzona 1391

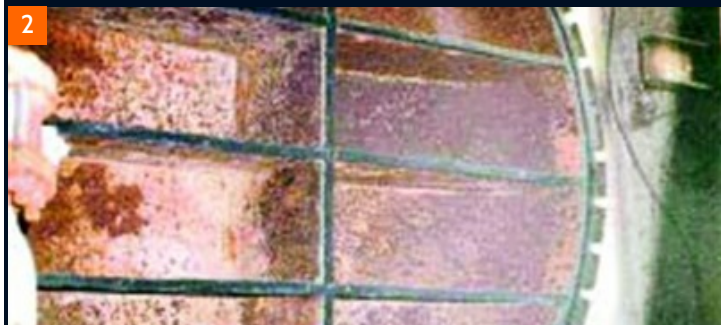
Extensive corrosion pitting.

Cast iron
