# BELZONA REFURBISHES EIGHTY YEAR OLD TURBINE RUNNER

ID: 2254

Severely eroded Francis turbine runner.

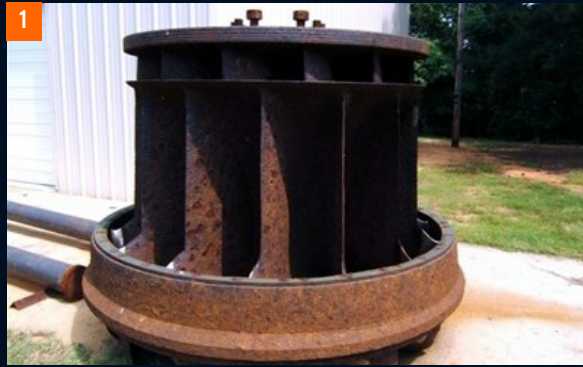
Years of use had caused severe corrosion and cavitation erosion on the turbine. Customer had received bids for new replacement but chose Belzona on economic grounds.

1. Turbine before initial blast cleaning
2. Some of the cavitation damage
3. Project after Belzona 1121 application
4. Completed project
