# BELZONA REPAIR AND PROTECTION OF SEA WATER LIFT PUMPS

ID: 2257

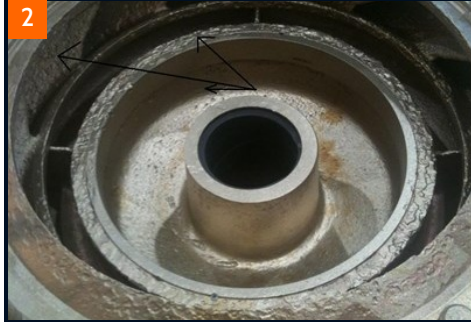
Pumps and various assembly parts were suffering from erosion and corrosion.

1. Application parts overview
2. Close up of corroded surface
3. Rebuilding with Belzona 1311
4. Complete application with 2 coats of Belzona 1341
