# BELZONA PROTECTION OF RISER BEND

ID: 2258

Riser bend on offshore platform.

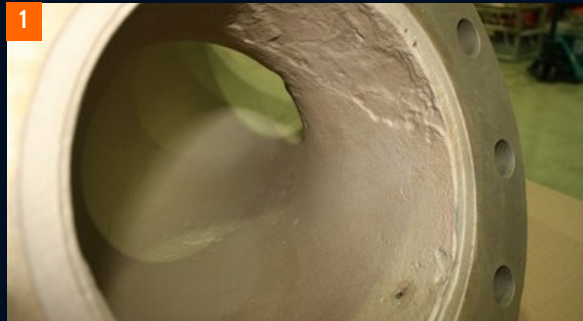
1. Riser bend overview
2. Internal Erosion Corrosion
3. Corroded areas rebuilt with Belzona 1311
4. Application completed with Belzona 1321 applied

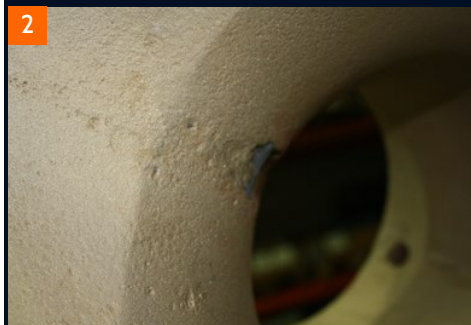
The riser bend was suffering from internal erosion corrosion.
