# IMMACULATE BELZONA HEAT EXCHANGER REPAIR

ID: 2259

Tube sheet from oil cooler on offshore production platform.

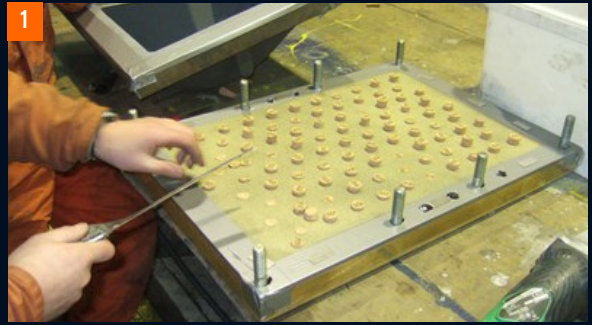
Surface of the tubesheet was badly corroded and required protection before leakage became an issue.

1. Gritblasted Tubesheet
2. Belzona 1391 applied to the tubesheet surface
3. Former plate coated with Belzona 9411 assembled
4. Completed Application, one perfectly formed and protected tubesheet

Application was carried out in accordance with Belzona System Leaflet HEX-1. Following gritblasting Belzona® 1391 was applied to the tubesheet. A special made former plate coated with Belzona® 9411 (Release agent) was assembled with 2mm spacers to ensure coating thickness. After 24 hours cure time the former was removed and the tubesheet put back into service.
