# BELZONA PROVIDES PROTECTION FOR VACUUM PUMP CONE

ID: 227

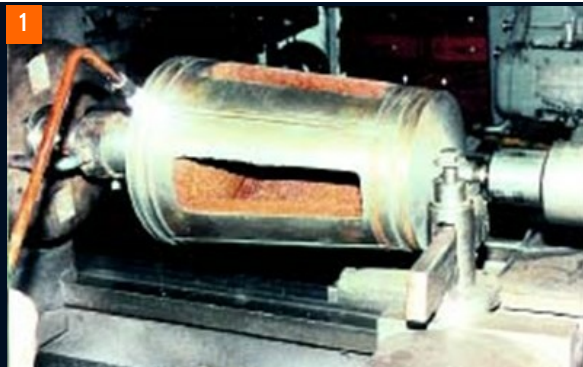
Erosion/corrosion damage can occur over the surface of a vacuum pump cone due to particle entrainment and chemical attack.

1. Removal of any of the cone's surface contaminants is treated with a torch
2. Use of Belzona 1111 to rebuild irregularities
3. Belzona 1341 provides final erosion/corrosion protection
