# BELZONA REPAIRS SUCTION DRUM EXIT

ID: 228

Exit section of a paper suction drum.

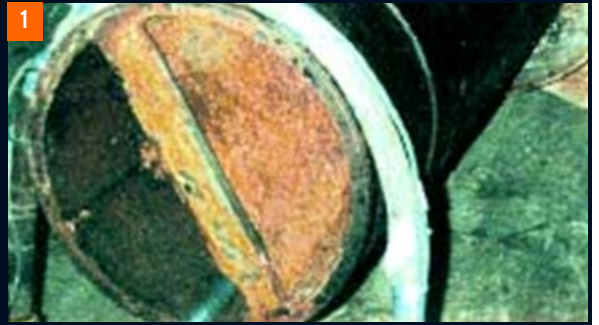
Severe corrosion produced by water and clay.

1. The equipment prior to repair
2. The surface has been prepared
3. Perforation repair using Belzona 1311 (Ceramic R-Metal) and perforated metal sheet
4. Equipment is ready to be put back into service
