# BELZONA SAVES SLUDGE PUMP

Badly corroded sludge pump.

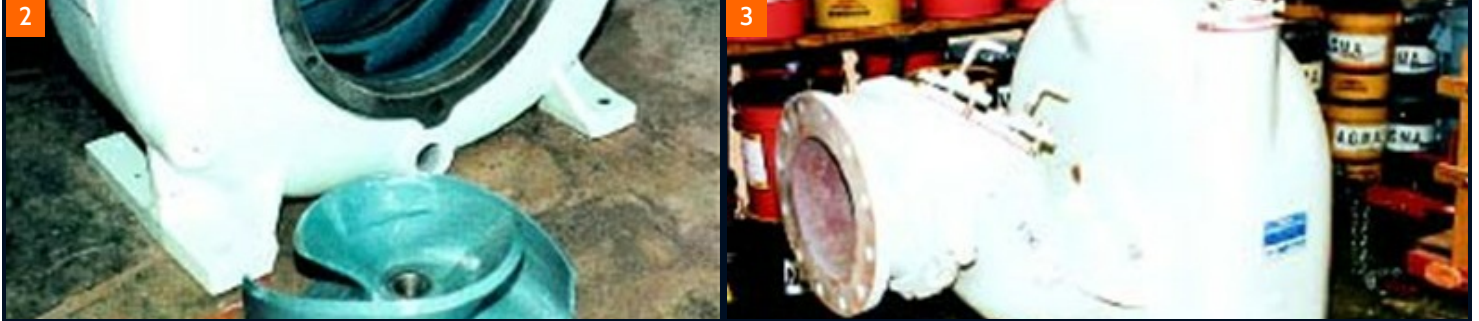
## PHOTOS

Impeller was frozen by rust. It would not turn.

1. Rusty impeller, frozen in place.
2. Impeller and internal casing coated with Belzona 1321 erosion- corrosion resistant coating.
3. The refurbished pump ready for service.

The application was carried out in accordance with Belzona Know-How System Leaflet CEP-5.

Belzona 1321 (Ceramic S-Metal)
