# BELZONA REFURBISHES STEPS AT HISTORIC COLLEGE

ID: 2299

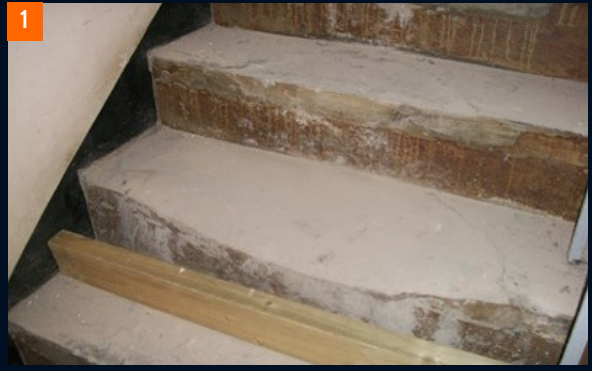
The steps had worn badly over the last few hundred years. The main contractor had to find a product that they could apply in the evening shift so the staircases could be re-opened ready for the busy work force in the morning to carry on with the rest of the project. The contractor only had six weeks to complete the total College refurbishment.

1. Worn steps before the application
2. Steps during the preparation
3. Steps rebuilt back to profile
4. Completed application ready for the overlay of carpet
