# BELZONA PREVENTS GALVANIC AND CREVICE CORROSION ON A RUDDER HORN

ID: 23

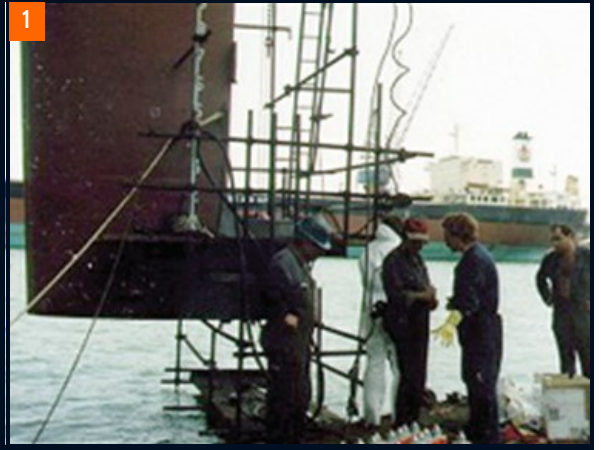
1. Belzona materials and team prepared for application.
2. Internal shot of bearing. Note arrows for injection ports.
3. Bearing after injection and prior to cleaning up of the Belzona 1211 seal.

The bearing was aligned and its position in the housing fixed using alignment bolts. The top and bottom of the housing were sealed using Belzona® 1211, then Belzona® 1321 was injected from below into the space behind.

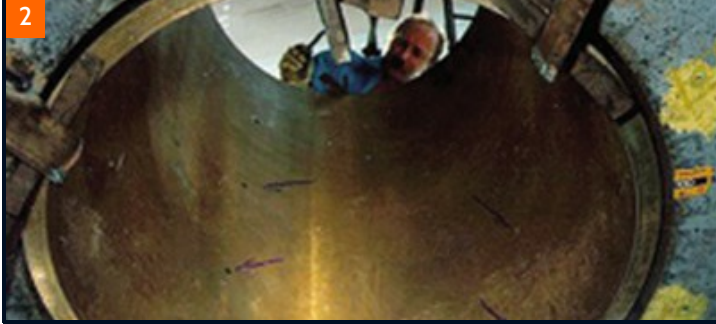
Corrosion of internal of Rudder Horn had allowed the press fitted bronze bearing to become free. Bearing was approximately 908mm (36-inch) diameter and 1050mm (41-inch) long.
