# BELZONA REPAIRS LARGE SOOT BLOWING AIR COMPRESSOR

ID: 231

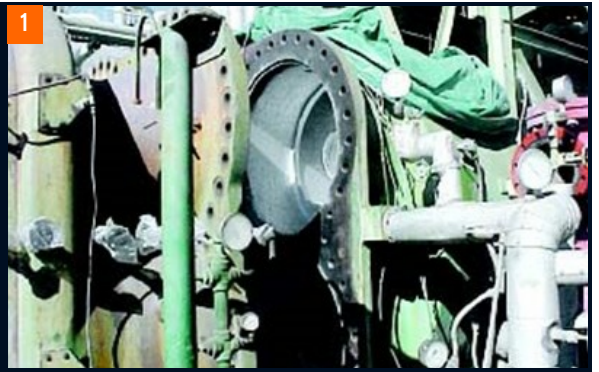
Corrosion in water jacket area had reduced the gasket sealing surface and allowed water into the air stream.

1. Overall view of soot blowing air compressor
2. Mold used to help form overlay for correct fit
3. Finished sealing area, lighter color (top) shows Belzona 1111 (Super Metal), darkest color is existing cast iron

The application was carried out in accordance with Belzona Know-How System Leaflet GSS-7. This method included grit blasting the area to be built up. A mold was used to help form the correct fit and a disc sander was used to achieve the proper finish.
