# BELZONA OFFERS COLD REPAIR SOLUTION TO PIPEWORKS

ID: 2316

Refinery in France

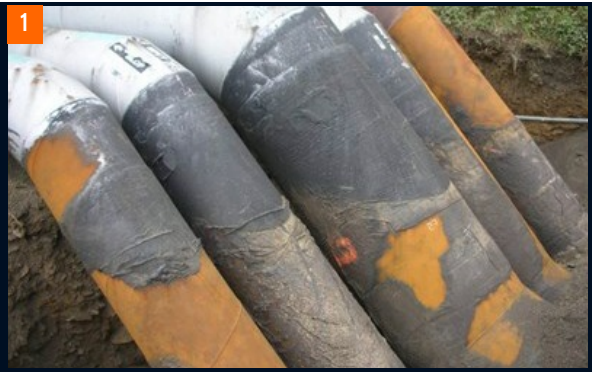
Previous coating did not last and external corrosion of the pipework was extensive.

The pipework close to the ground is constantly exposed to water and mud.

1. Failure of the previous coating
2. Repair using Belzona 1121 and reinforcement tape
3. Extra corrosion protection being provided with Belzona 5811 coating
4. Repair completed
