# BELZONA REPAIRS PIPES TRANSPORTING SULFURIC ACID

ID: 232

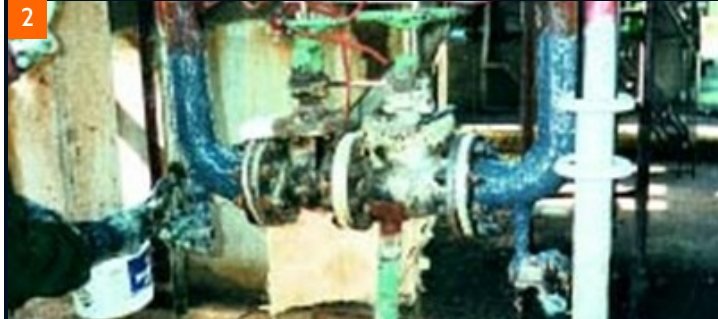
Thin spots were detected on the pipe by UT inspection. The pipe required reinforcement.

1. Following surface preparation by cleaning, Belzona 4301 was applied with reinforcement tape
2. Finishing touches with a top coat of Belzona 4311
3. Finished job
