# BELZONA REBUILDS SLUDGE PUMP COMPONENTS

Rebuilding of sludge pump components.

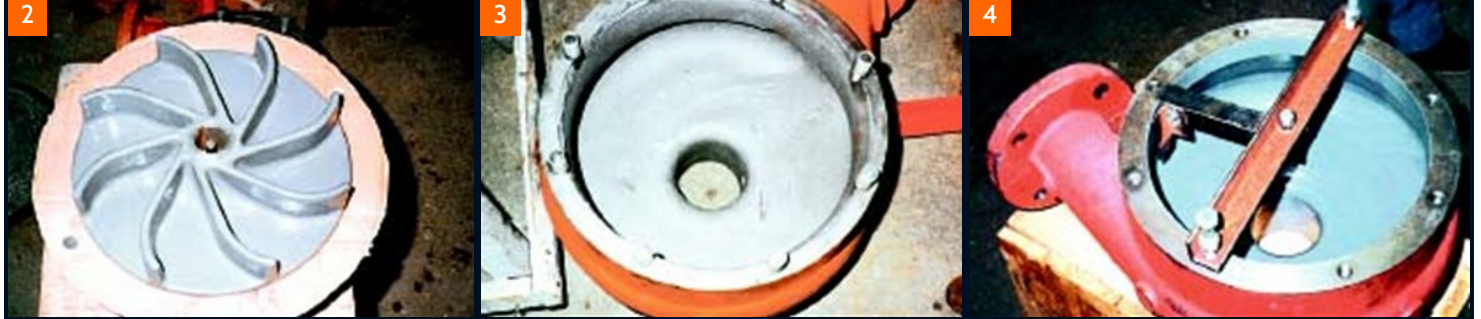
Severe erosion had caused unacceptable pump performance.

1. Backing plates - before and after the Belzona repair.
2. The new impeller was also protected.
3. The eroded casing.
4. The entire casing was rebuilt with Belzona 1311 (Ceramic R-Metal), and protected with Belzona 1321 (Ceramic S-Metal).

The application was carried out in accordance with Belzona Know-How System Leaflets CEP-3 and CEP-5.

Belzona 1311 (Ceramic R-Metal)  
Belzona 1321 (Ceramic S-Metal)
