# BELZONA REPAIRS WASTEWATER PUMP

ID: 234

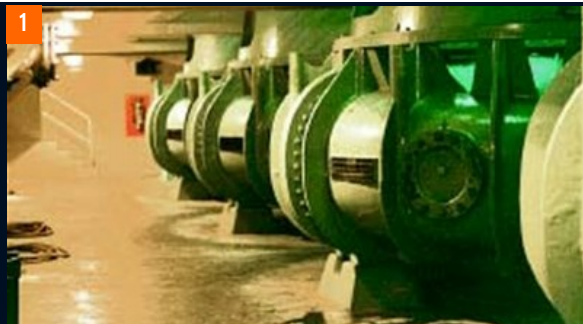
1. Large centrifugal pumps
2. Pumps disassembled for repair
3. Volute rebuilding in progress
4. Rebuilding in progress

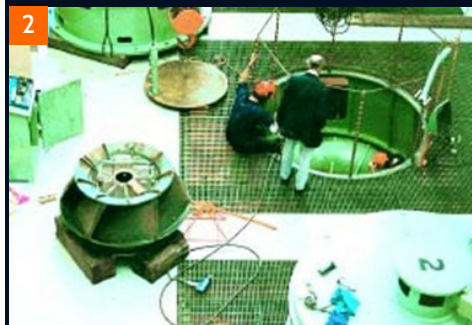
Pumps were suffering from severe erosion around the volute. It was difficult to remove the unit for repair due to its size and location.
