# BELZONA REPAIRS FAN AT PULP AND PAPER MILL

ID: 235

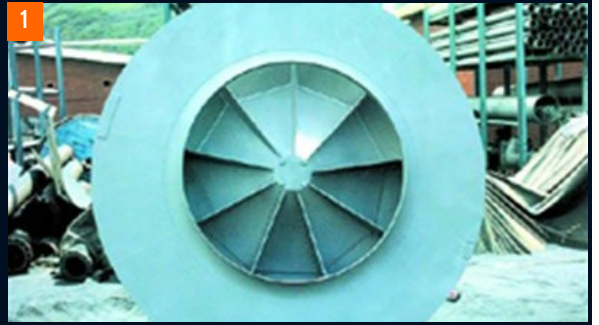
Magnesium Oxide fan and casing were being destroyed by a serious corrosion/erosion cycle. The process temperature was 150-165C. Although the process is dry, moist air was being sucked in through the shaft hole, corroding the steel.

1. The fan has been grit blasted and is ready to be coated
2. The top of the fan casing has been coated with Belzona 6111 (Liquid Anode)
3. Belzona 5111 (Ceramic Cladding) is being applied to the fan casing bottom

An imitation product had been previously used and only lasted for 10-12 months. The engineers chose Belzona for a more long lasting, cost effective solution for the fan and casing. The fan blades were coated with Belzona® 1391 for outstanding erosion/corrosion protection.
