# BELZONA ALL THAT ITS CRACKED UP TO BE

ID: 236

Raw sugar storage area.

Sugar beet mill - Minnesota, U.S.A.

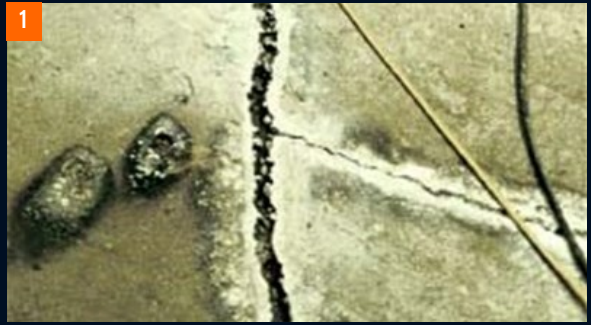
Raw sugar and ambient moisture create an erosive environment over the concrete surface. Over time, the floor's surface spalls and creates safety hazards.

1. View of damaged floor
2. Cracks are being V-cut and terminated
3. Spalled area and cracks have been repaired with Belzona 4111
