# BELZONA LEVELS LOADING QUAY

ID: 2365

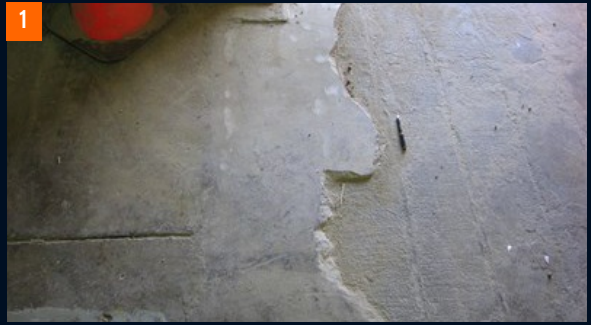
A less costly alternative repair had lasted only 6 month (picture 1). Belzona 4111 is still intact after 1 year in service, due to its excellent bond strength, impact resistance and compressive strength.

1. The failed previous alternative repair
2. Surface preparation
3. Completed application
4. Application after 1 year
