# BELZONA REJUVENATES STEEL PLANT ACID & CAUSTIC BUNDS

ID: 2371

Basic Oxygen Steelmaking (BOS) Demin water plant. Two bunds for regeneration chemicals - 96% sulphuric acid and 46% Sodium hydroxide.

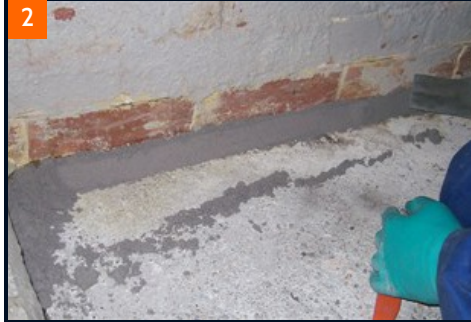
The two bund areas needed complete refurbishment. Over the years acid and caustic residues had attacked the bunds and left them both badly deteriorated. The client wanted the area cleaned and protected with a material that would resist further attack.

1. Original condition with Acid & Caustic attack
2. Fillet created in Belzona 4131
3. Finished system in Belzona 4311
4. Acid and Caustic bunds completed in Belzona 4311
