# BELZONA PROTECTS RIVER BARRAGE 12 YEARS ON

ID: 2374

Flood defence barrage on tidal river.

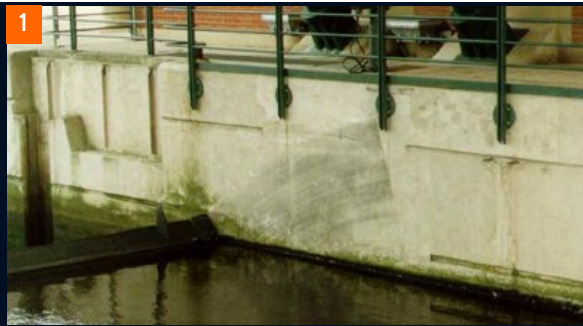
The Tees Barrage was opened in 1995 with a designed life of 120 years. However, the client quickly found the rubber seals on moving gates were being damaged by the concrete walls when the barrage gates were raised and lowered. Trials were conducted for potential solutions in 1997 and only the Belzona application proved itself in practice.

1. Clear evidence of abrasion on concrete from the rubber seals in 1997
2. Completed application of Belzona 1341 in 1999
3. Still in service over 12 years later in 2011
4. No breakdown of Belzona 1341 on any of the 4 barrage gates spanning the Tees in 2011

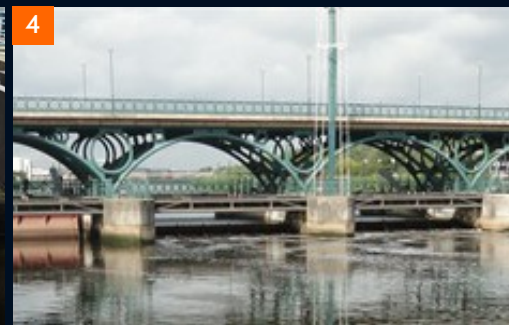
The full scale application only proceeded once the initial trial had proven successful. A competitor's system had also been tried but wasn't able to be applied successfully. 4 gates each had 2 arcs of Belzona® 1341 applied, totalling about 400m<sup>2</sup>. To date, the application is over 12 years old and, although each gate undergoes annual inspection, there has been no sign of any breakdown in any of these areas.
