# BELZONA PRE-STRESSED CONCRETE BEAMS

ID: 24

Scale Beams of the refinery truck scale, originally installed in the 1970s.

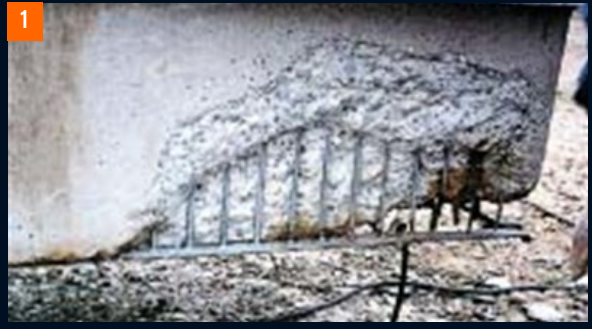
Concrete severely eroded over time.

1. Area of worst damage, re-bar and bottom metal spine being repaired.
2. Application in progress. Note the polyethylene covered plywood being used as a former.
3. Completed repair.

Application was carried out in accordance with a modified version of Belzona Know-How Leaflet TCC-9.
