# BELZONA 5811: EXCEEDING WHERE OTHERS FAIL

G.E. Condenser (Generator) Water Box

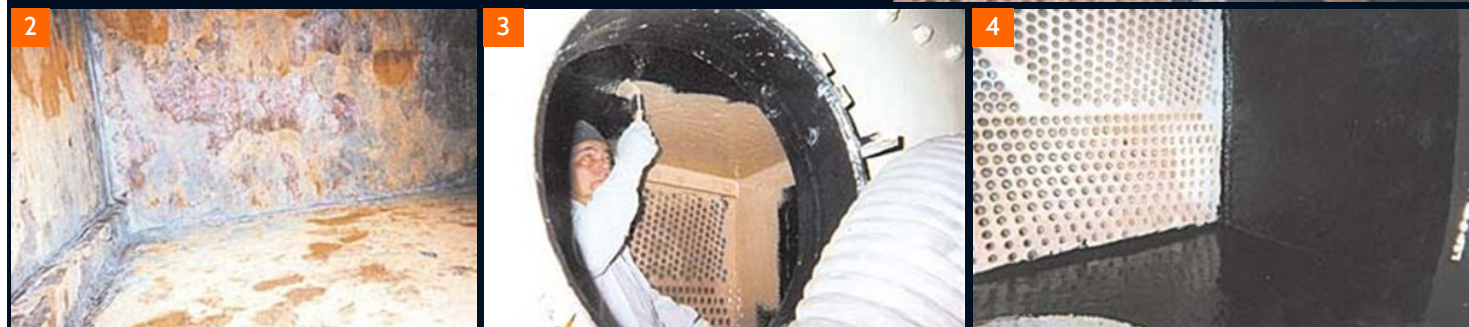
Previous coatings had failed in a very short time. Loss of imitator coating and severe corrosion were causing the blockage of tubes, thus reducing efficiency of unit.

1. Corroded water box
2. Another view of the corrosion
3. Belzona 5811 was brush applied in a two coat process - black over tan
4. Completed application of Belzona 5811

The application was carried out in accordance with Belzona Know-How System Leaflet HEX-3.
