# BELZONA RESTORES FOUR CONDENSER TUBE SHEETS IN FIVE DAYS

Condenser tube sheets of 350 MW generator - each contains 6, 453 tubes.

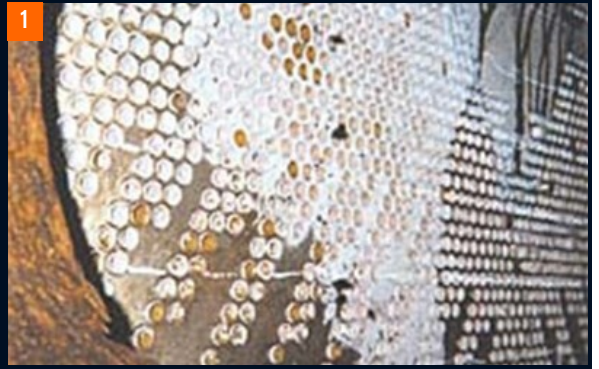
Insertion of new stainless steel sleeves caused ligament damage to the inlet tube sheets resulting in severe tube to tube sheet leaks and a forced outage.

1. Initial view of bottom of one tube sheet prior to grit blasting
2. Application of Belzona 1121 and Belzona 1341 underway
3. Completed tube sheet ready to go online
