# BELZONA CRUSHES ANOTHER PROBLEM

During a maintenance outage, the plant's 34-ton rock crusher's main bearing saddles were showing unacceptable levels of wear.

A 34-ton rock crusher.

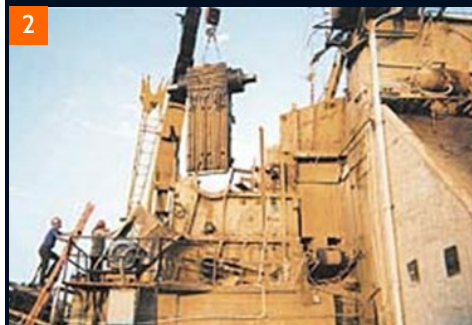
An overview of the quarry An overview of the rock crusher The Belzona 1121 (Super XL-Metal) being applied The equipment being reassembled

The application was carried out in accordance with Belzona Know-How System Leaflet MPT-7 using Belzona® 1121 (Super XL-Metal) due to the extreme summer heat and long time required to "reset" the equipment via crane.
