# BELZONA GIVES NEW LIFE TO POWER PLANT ROOF

ID: 243

Nuclear Power Plant, Maryland

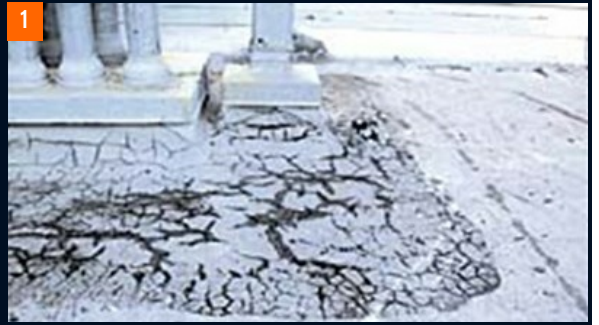
The traditional built-up roof and conventional roof system with insulation had failed with numerous leaks. Previous attempts to repair the roof had failed so the power plant turned to Belzona for a long-term solution.

Deteriorated built-up roof, leaks, numerous roof penetrations for HVAC etc.

1. Existing condition
2. Completed area
3. Another view of the roof area completed

Conventional roofs were explored but Belzona Flexible Membrane was the only product to provide a completely seamless surface to the degree the power plant desired. The savings achieved will allow the plant to complete two additional roofs that were previously unable to be funded.
