# PROTECTION COATING APPLICATION ON A BULB GROUP

ID: 2448

Bulb group

Hydropower plants / France

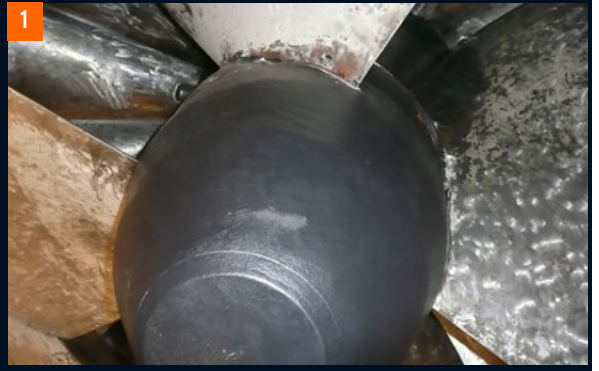
The hub's painting was damaged because of the engineers pinholes.

1. Hub with existing painting
2. Painting grinding to remove non-adherent parts
3. Substrate blasting (steel and remaining painting)
4. Completed coating with Belzona 1321

The application was carried out according to the Belzona Know-How Leaflet CEP-4. After the surface preparation by grinding and blasting, a complete coating was applied in 2 coats of 250 µm on the hub.
