# BELZONA PROTECTS CYCLONES

ID: 2449

Cyclone used to dewater drilling mud produced by tunnel boring machine.

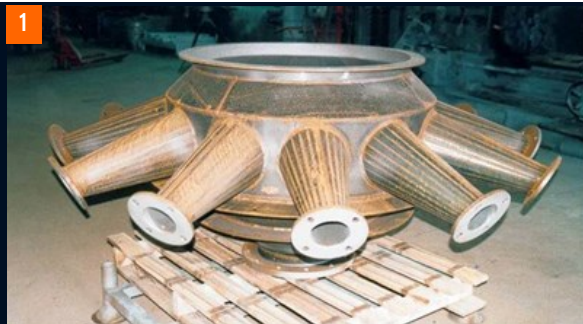
Severe abrasion due to the wet mud. The original bonded rubber lining usually used is difficult to repair insitu due to the complex surface geometry.

1. Cyclone head
2. Interior of the cyclone after blasting
3. Interior of the cyclone after the application of Belzona 1812
