# BELZONA REPAIRS COLLEGE STEPS

ID: 2451

Damaged steps at public college

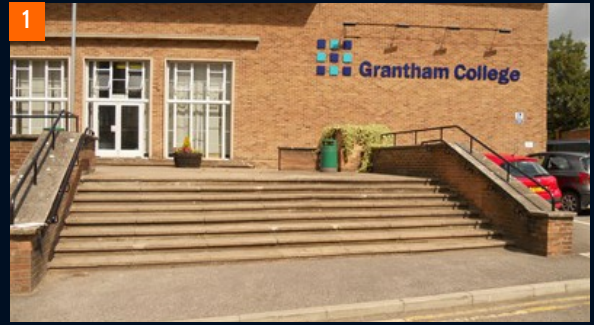
Heavy foot traffic and weathering caused the steps at this college to become damaged and worn.

1. General view of the damaged steps
2. First application of Belzona 4131
3. Application being carried out
4. Finished application
