# BELZONA REPAIRS ARMY VEHICLE

ID: 2452

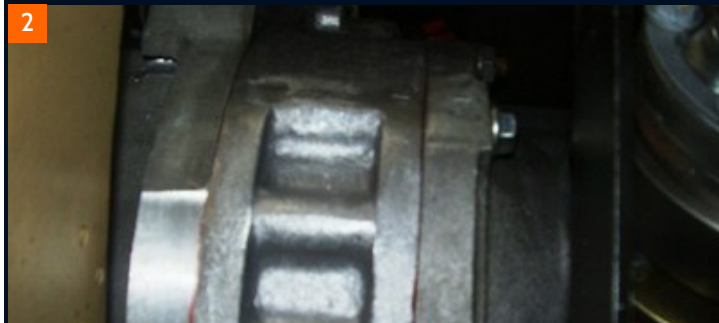
The vehicle's gearbox casting was porous leading to unacceptable oil loss.

1. The Jackal
2. The porous gearbox casting before application
3. The gearbox sealed with Belzona 1161
