# BELZONA REPAIRS 315 KW MOTOR SHAFT

ID: 2454

315 kW electric motor shaft

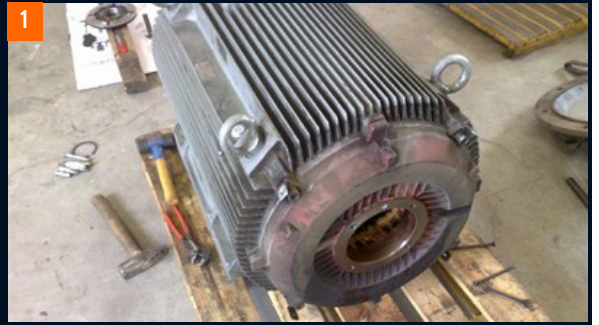
Shaft had been damaged by failed bearing.

1. Electric motor case
2. Damaged shaft
3. Machining of the Belzona 1111
4. Completed job

Application was carried out in accordance with Belzona Know-How System Leaflet MPT-1. Shaft was turned down and left with coarse thread before being rebuilt with Belzona® 1111 followed by machining back to original diameter.
