# BELZONA PROTECTS PIPELINE AND VALVES FROM CEMENT ABRASION

ID: 2455

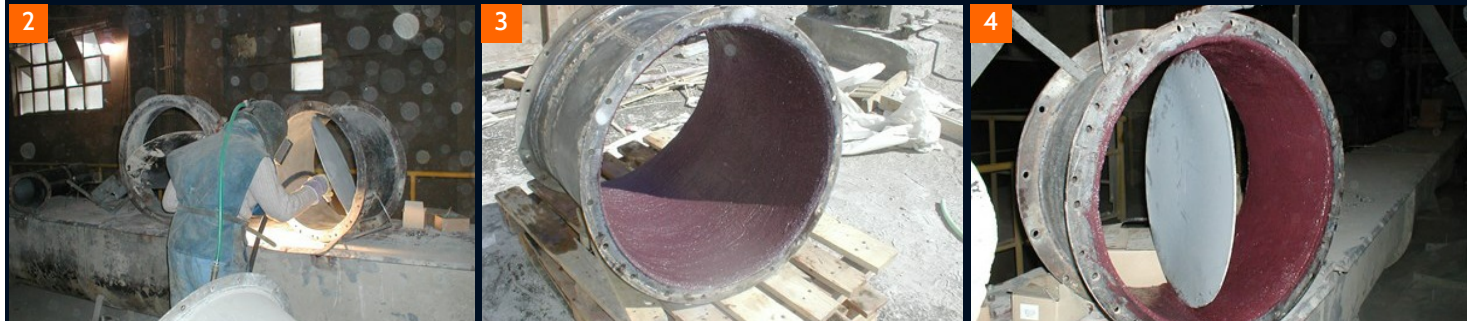
There was high abrasion caused by cement leading to local material loss of metal from valve body.

1. Badly eroded valve
2. Grit blasting the valves
3. Completed valve body
4. Re-assembled valve protected with Belzona 1811

Application was carried out in accordance with Belzona Know-How System Leaflet VPF-11.
