# BELZONA STOPS FLOOR DRAIN LEAKS

ID: 2458

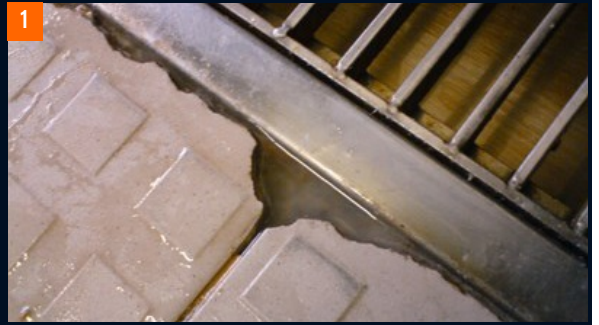
Leakage from the floor drains was problem from the start. Connection between steel and tiles was faulty. Result was the leakage to the next floor.

1. Situation before repair
2. Situation at the floor below
3. Surface preparation being carried out
4. Belzona 4111 in place creating a watertight seal
