# BELZONA REPAIRS PUMP CASINGS AND ADHERES TO ALL SURFACES

ID: 2463

Centrifugal Pump

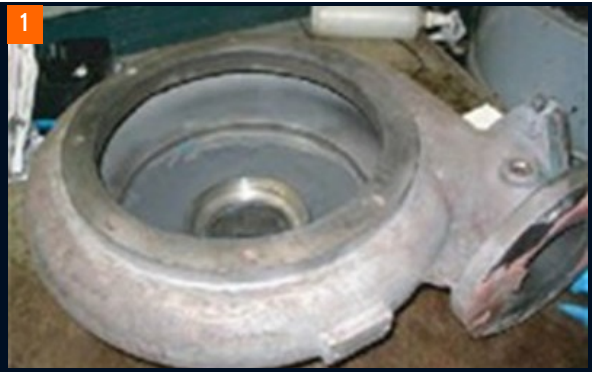
1. Reconstruction with Belzona 1311 (Ceramic R-Metal)

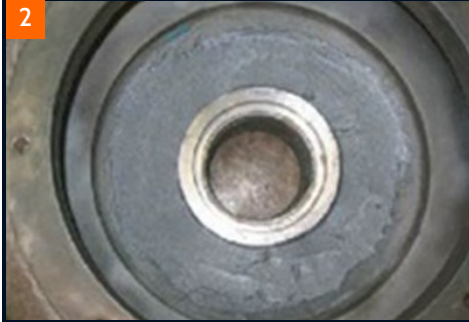
2. View of the reconstruction.

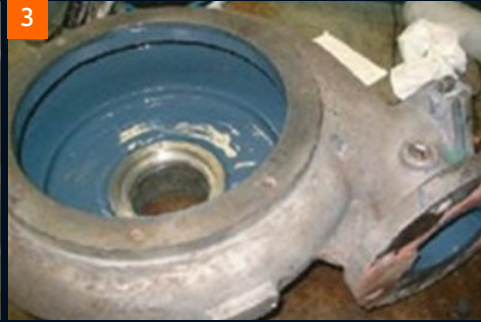
3. Application of Belzona 1321 (Ceramic S-Metal) to protect the pump

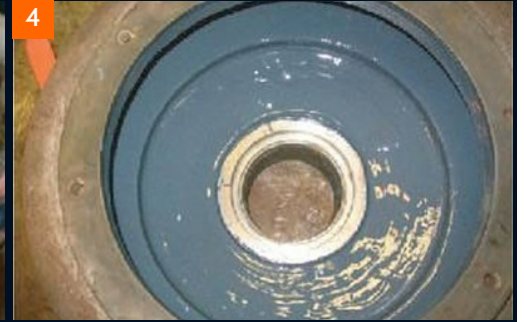
4. Completed Application
