# BELZONA SEALS FOUNTAIN LEAKS

ID: 2465

Millennium Fountain, South West England

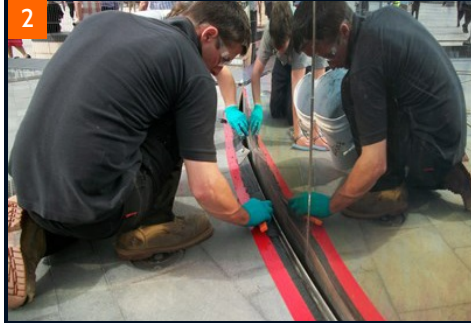
After 11 years of service the Millennium Fountain started to leak from between the base and the side wall interfaces within the pond areas. The water was leaking onto the pathways and staining the side walls of the fountain. Also the cost of the water loss was running into thousands of pound per year.

1. Failed fillets within the fountain
2. Building the new Belzona 4111 fillets
3. Belzona 4111 fillets completed and the slate joint being filled with the slurry mix
4. Completed application with the fountain refilled and back in use

The application was carried out in accordance with Belzona Know-How System Leaflet FPA-3. The existing failed rubber fillets were removed; the joints were then dried out and prepared to a good firm dry substrate. After carefully masking the area a fillet of Belzona® 4111 was applied between wall and floor in the pond areas. The Belzona® 4111 was tinted to match the slate colour. A slurry mix of Belzona® 4111 was also poured to seal between the slate slabs.
