# BELZONA PUTS A STOP TO WATER INGRESS IN PARKING GARAGE

ID: 247

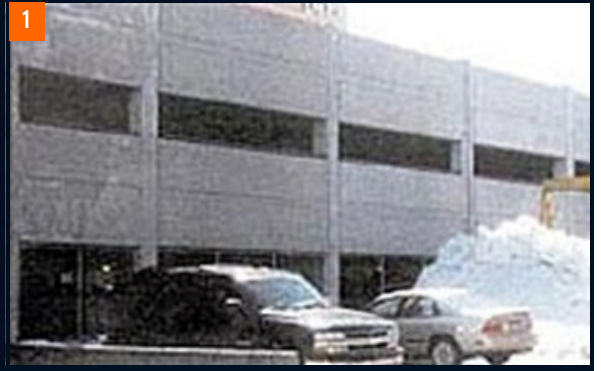
1. General view of the parking garage
2. Joint cleaning and placement of foam backer rod
3. Surface preparation
4. Completed expansion joint at top level of the building

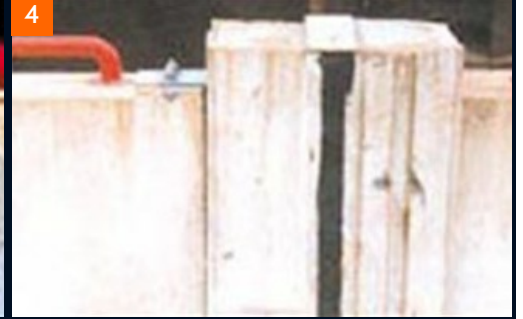
The original expansion joint was damaged after six years, which allowed water filtration two levels down.

Due to thermal cycling, the joints broke down prematurely. The Belzona Solution has been in place for over three years with no signs of leakage.
