# BELZONA SECURES DANGEROUS WALKING AREAS

ID: 2476

Stairs and walkway areas accessing a municipal building.

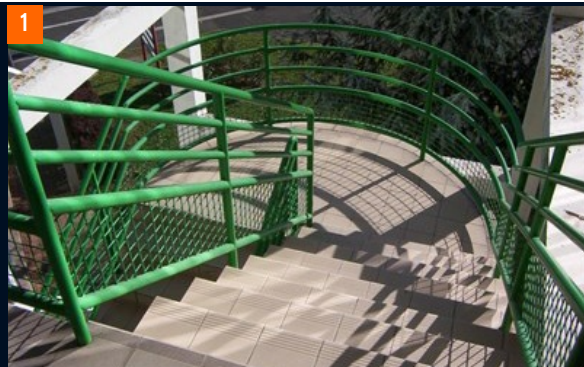
The stairs and walkways, located outside, were very slippery when wet.

1. The external staircase
2. Completed application on the stairs
3. Application in progress on the walkways using stencil to create pattern
4. Completed application on the walkway
