# BELZONA SECURES THE TOWN HALL STEPS

ID: 2477

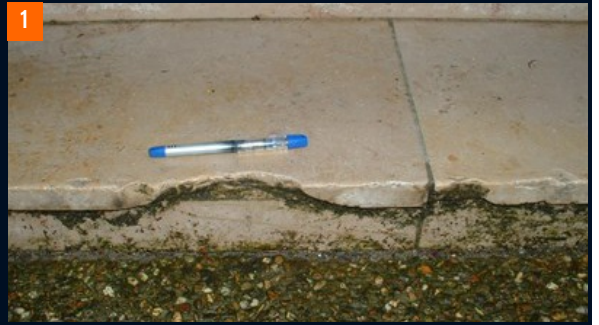
The steps were damaged through impact and were extremely slippery when wet.

1. Close view of the damaged steps
2. Side view of the steps
3. Steps rebuilt with Belzona 4111
4. Completed application with Belzona 4411 grip system applied to leading edges
