# BELZONA REPLACES NON-SLIP TAPES ON RAMP

ID: 2479

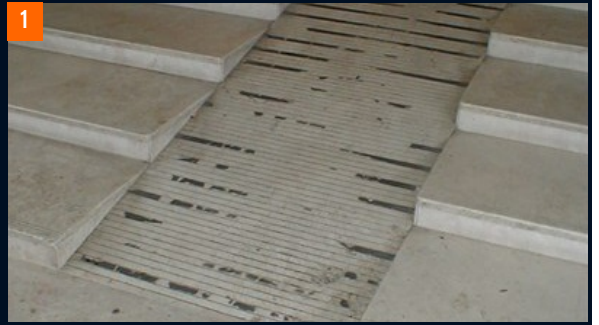
The ramp was a potential slip hazard and adhesive tapes had been unsuccessfully used to create a non-slip surface. A more positive, long term solution was required.

1. Ramp with failed tape system clearly evident
2. Ramp after application of Belzona 4411
3. Close view of the application
4. General view of the ramp at the hospital entrance
